21154 PCI-to-PCI Bridge

Specification Update

July 2004

Order Number: [278295-017](#)

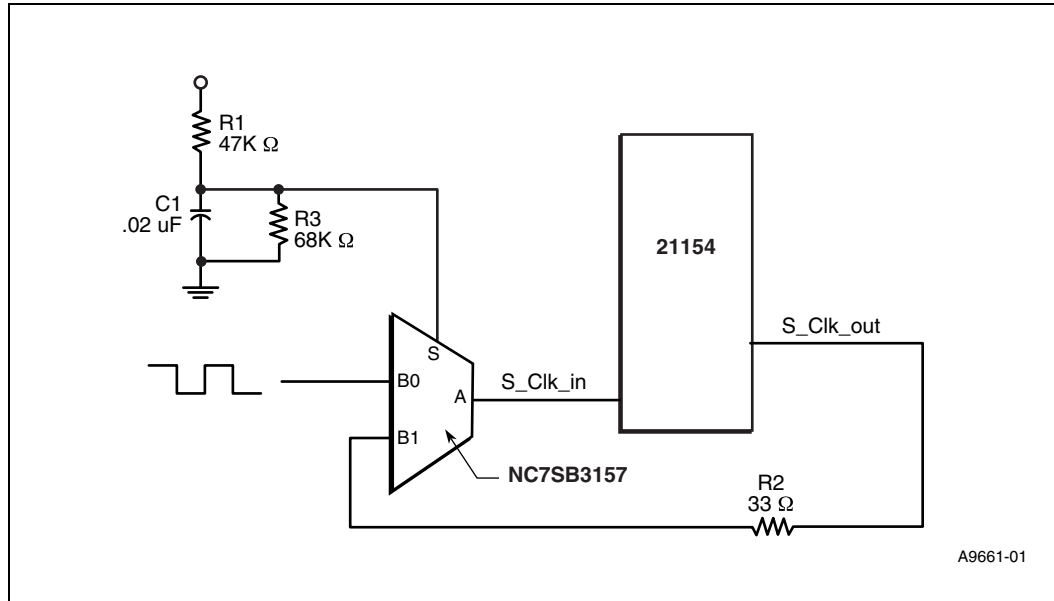
Figure 1. S_Clock Multiplexer Workaround Circuit for Errata 6.

6. Secondary Clocks Outputs s_clk_o<9:0> May Not Start-up Properly Under Some Conditions

Problem: This problem has been found on the 21154AC and 21154BC. Under repeated and frequent power cycling, the secondary clock circuits may not power up in the proper state, resulting in the device not coming out of reset after power up.

Implication: In a system with a 21154AC or 21154BC that has one of its s_clk_o<9:0> outputs fed back to provide the s_clk, it is possible that the s_clk_o<9:0> output clocks will be driven and remain low, keeping s_rst_l asserted, during system power up.

This happens occasionally when a latch whose output disables the serial shift registers on the Secondary clock control powers up in a high state and the shift register bit corresponding to the s_clk_o<9:0> output that is fed back also powers up in the high state.

1. [Figure 1](#) illustrates the first recommendation - a circuit where an on-board pulse source is gated via the B0 input of the multiplexer to the S_Clock_in pin of the 21150.

At time 0, the S input of the multiplexer is low, allowing pulses from the on-board pulse source, connected to the B0 input, to be provided to the 21150 S_Clk input pin. When the time determined by the R/C network is satisfied, the S input pin will be in a logic High state. The multiplexer will then shut off the input pulse from S0 and will direct the S_Clock_out pulses via the B1 multiplexer input, into S_Clock_in

The values used for the R/C network should be selected to allow a minimum of 2 pulses to be delivered to the 21150 after Vdd has reached 3.0V at a frequency not to exceed the appropriate PCI component. i.e. 30 ns for a 33Mhz bridge. These values should be chosen based on the rise time of the power supply and the frequency of the on board pulse source. The values given for R1, R3, and C1 are for example purposes only.

Note: The NC7SB3157 2:1 Multiplexer / Demultiplexer Bus Switch used in this example has a maximum propagation delay of 800ps that should be taken into consideration when matching trace lengths of the clock lines to avoid introducing excessive skew in the clocks. All S_Clock etch lengths must be matched to within 2ns @ 33Mhz or 1ns @ 66Mhz. The addition of this circuit requires that the etch length for the S_clock_in signal be reduced to compensate for the 800ps delay.

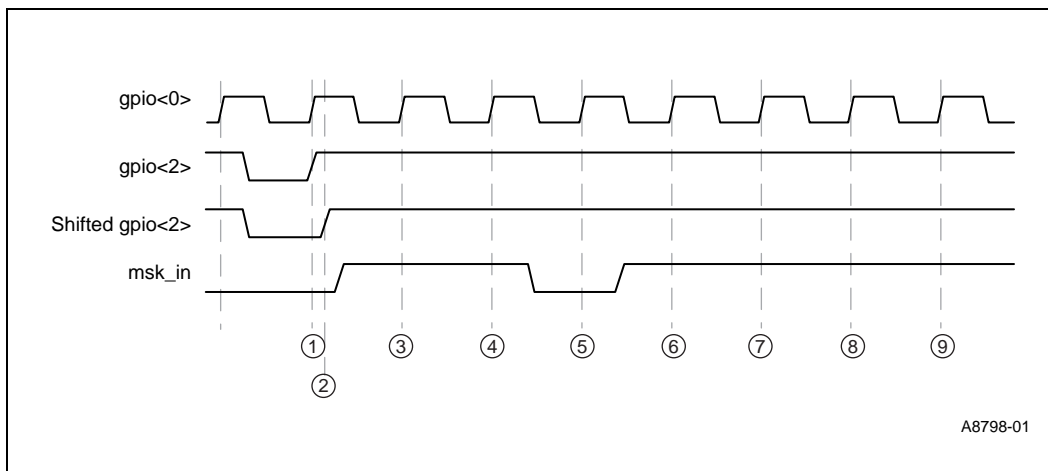
Figure 21. Clock Mask and Load Shift Timing

1. The **gpio<2>** original coming from the 21154 does not provide 3ns setup time needed to provide the parallel load enable **PE#** of the 74F166.
2. The shifted **gpio<2>** is delayed by ~9ns to provide ample setup time to enable the parallel of the shift register connected to pin 15 of the 74F166.
3. Bit 15 input **D6** of the shift register is pulled high, to Vcc.
4. Bit 14 input **D7** is pulled high, to Vcc. These signals are not used internally in the 21154.
5. Bit **13 s_clk_o<9>** is a feedback to the 21154 **s_clk_o** input. To enable **s_clk_o<9>** in all cases the **D5** input of the shift register is grounded, to Vss.
6. Bit 12 **s_clk_o<8>** is disabled.
7. Bit 11 **s_clk_o<7>** is disabled.
8. Bit 10 **s_clk_o<6>** is disabled.
9. Bit 9 **s_clk_o<5>** is disabled.
