MEMORANDUM

Bendix
Computer

SUBJECT: Errata

EXPLANATORY NOTES ON ECO #1096

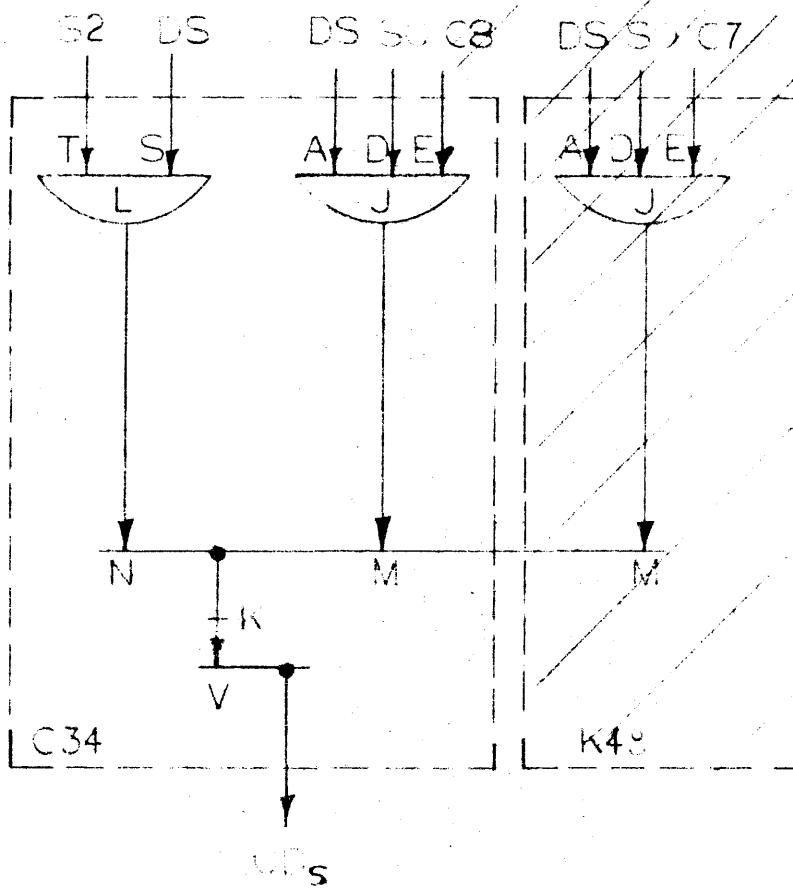
To insure reliable operation of the G-15 input-output system in the standard mode, "READY" is now used to reset the AS (Automatic-Standard reload) flip-flop. This means that if an automatic mode input is going on, it is necessary to wait for "READY" (or give the "Set Ready" command) before initiating a standard mode input or output. If the neon is on, S must be typed before Q or P to gate numeric type-in or photo tape read, respectively. (See figure 1)

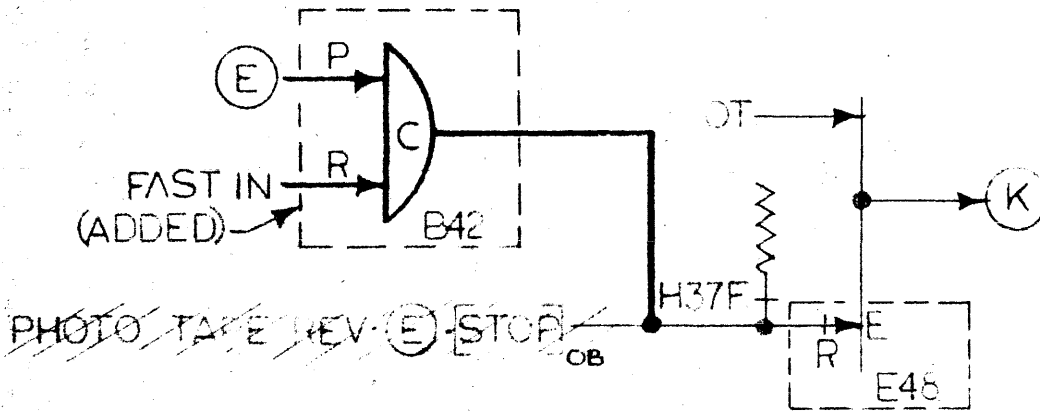
FIG. 2

A modification was recently made to allow blank leader on the MTA-2 without causing a precession of M19. Since machines with serial numbers less than 210 do not contain this change, it is not desirable to write programs using this feature. Therefore, the modification was removed and the diodes used to clean up other signals. (See figure 2)

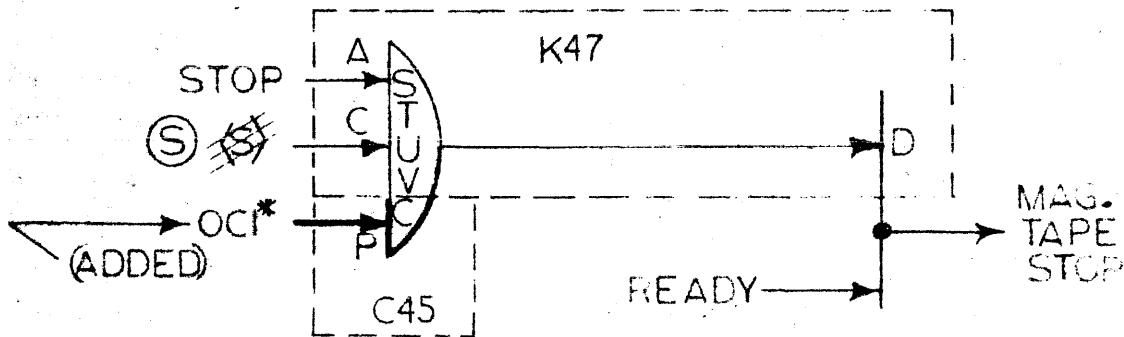
FIG. 3A

Erroneous stop codes will no longer be encountered during acceleration of magnetic tape when starting in the midst of data. Also, approximately 60 ms. of overshoot was added on searching magnetic tape in reverse for stop codes. This was done since the MTA-2 stops so quickly in this mode that the stop code is sometimes missed in a following forward operation. (See figure 3)

TO ELIMINATE ERRONEOUS STOP CODES DURING ACCELERATION OF MAGNETIC TAPE.

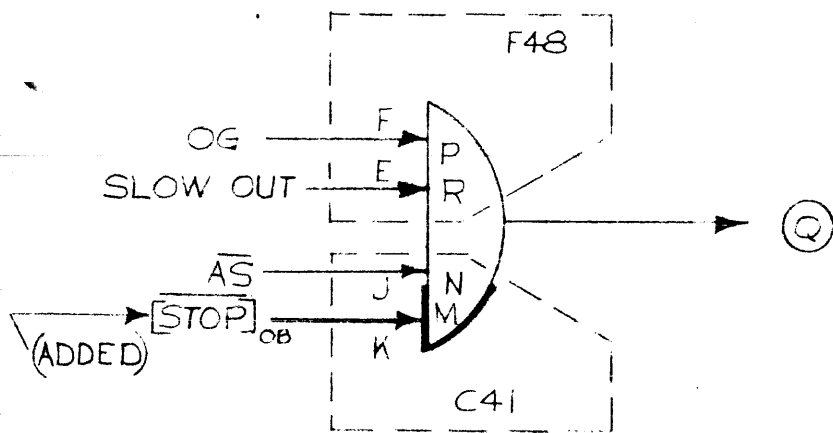
FIG 3B

TO CAUSE OVERTHOOT ON MAG. TAPE REVERSE.
 NOTE: THE CHANGE OF (S) TO Ⓢ IS NOT A LOGIC CHANGE BUT THE CORRECTION OF A DRAFTING ERROR.

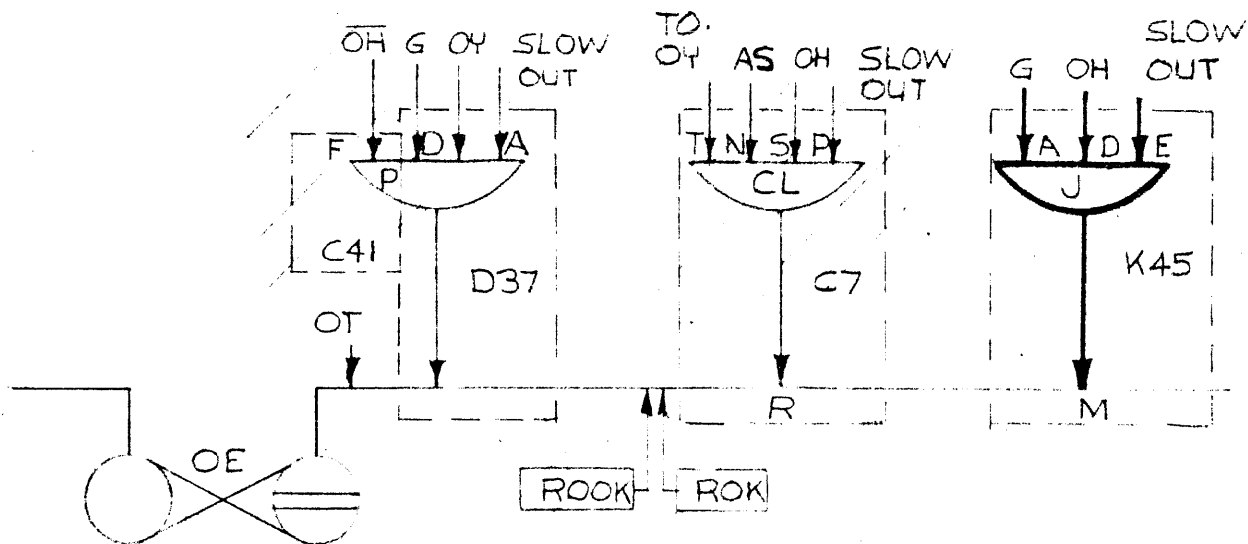
FIG. 4

It was logically possible for a simple type-out of AR to cause a four-word precession of M19, although cases of this happening were few.

However, further qualification of C by [STOP]_{os} eliminates this possibility. (See figure 4)

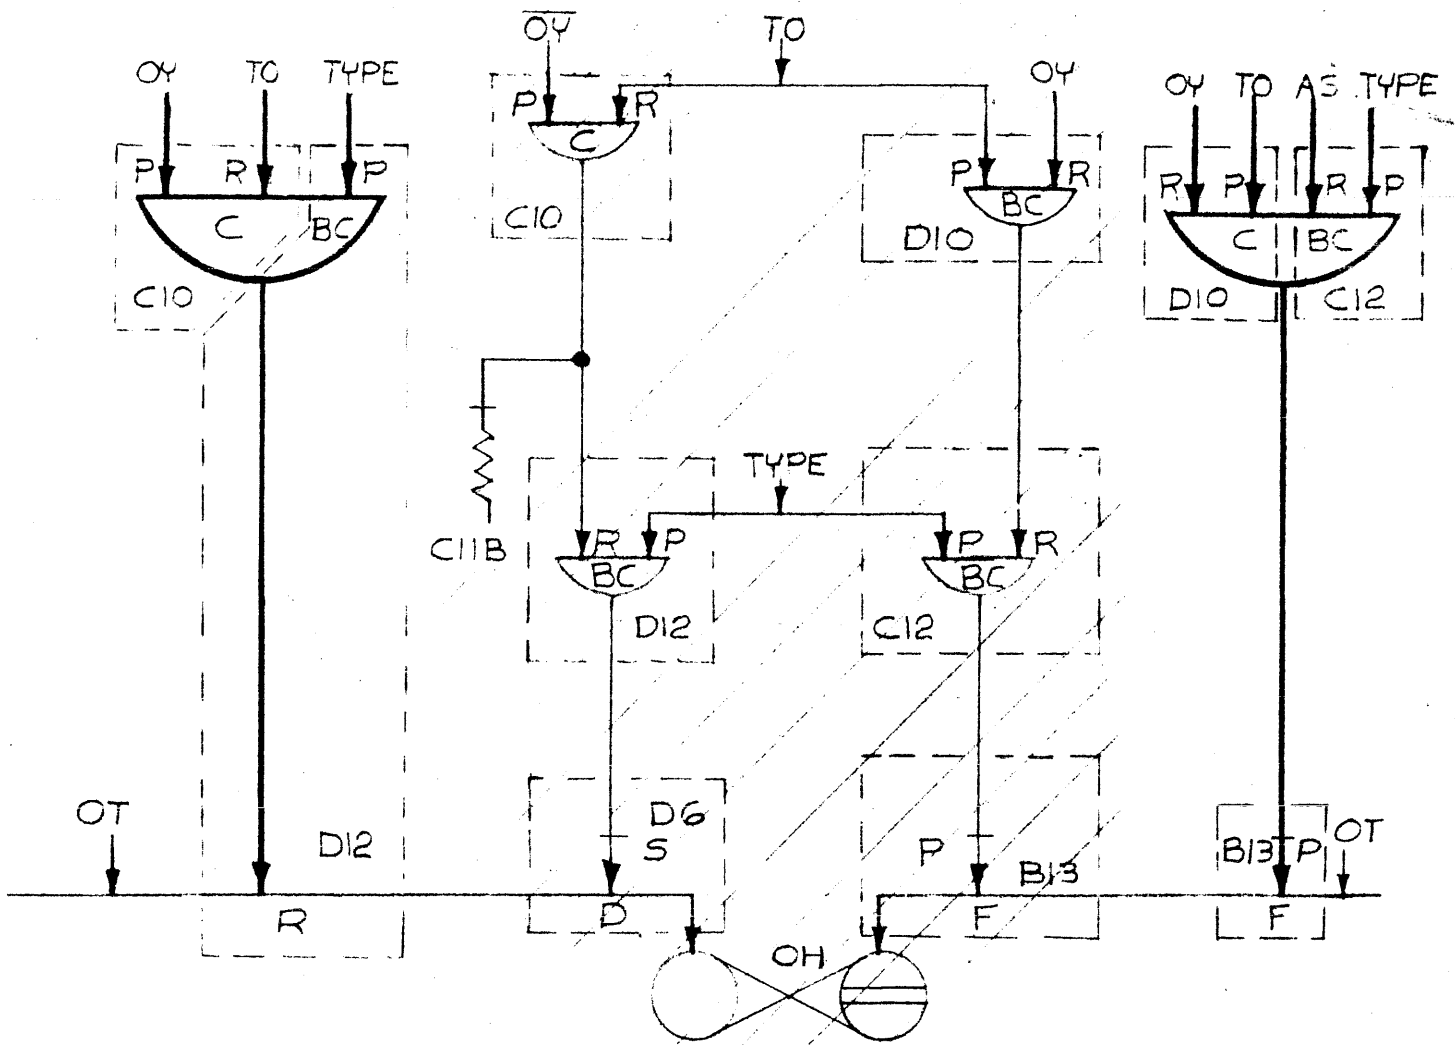
FIG. 5

The slow out timing logic was revised to make it more reliable and to use

less components. The big changes were to remove the fake feedback loop involving the HC Buffer-inverter and qualifying the setting of OH with AS so that OH would not be used during numeric type-out. (See figures 5, 6, 7, and 8)

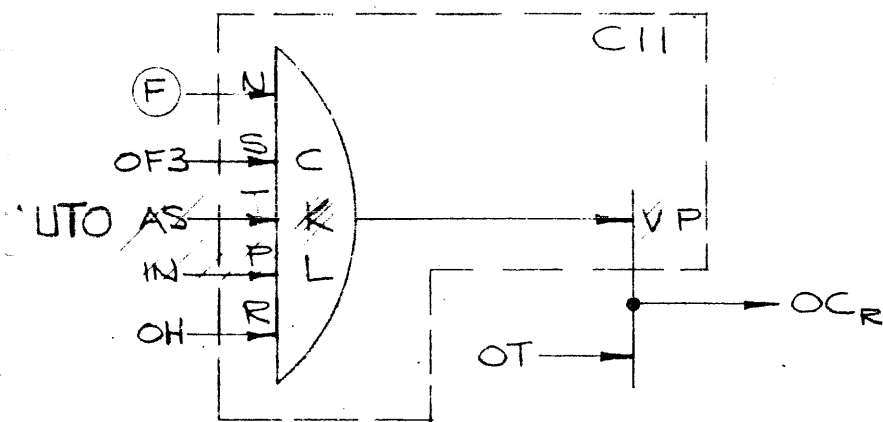
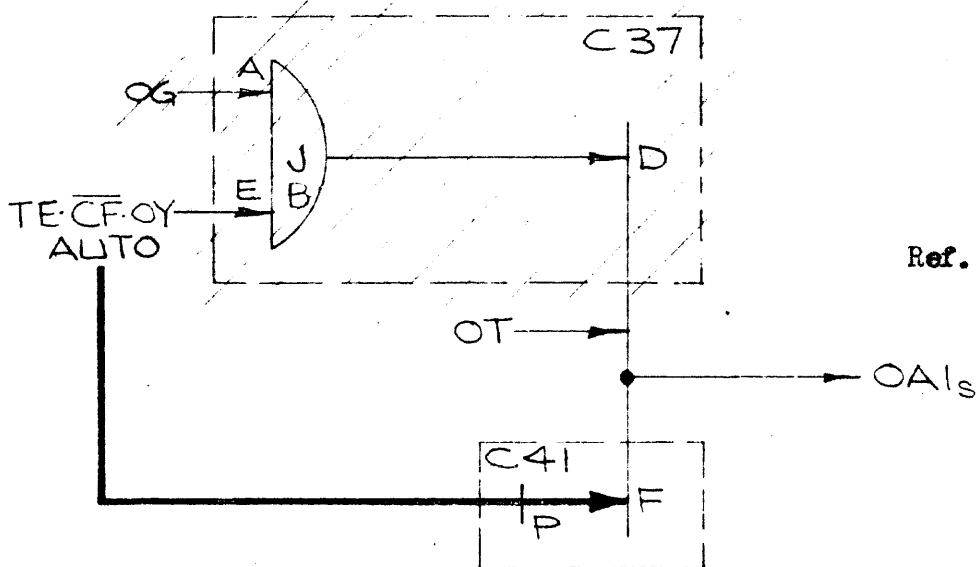
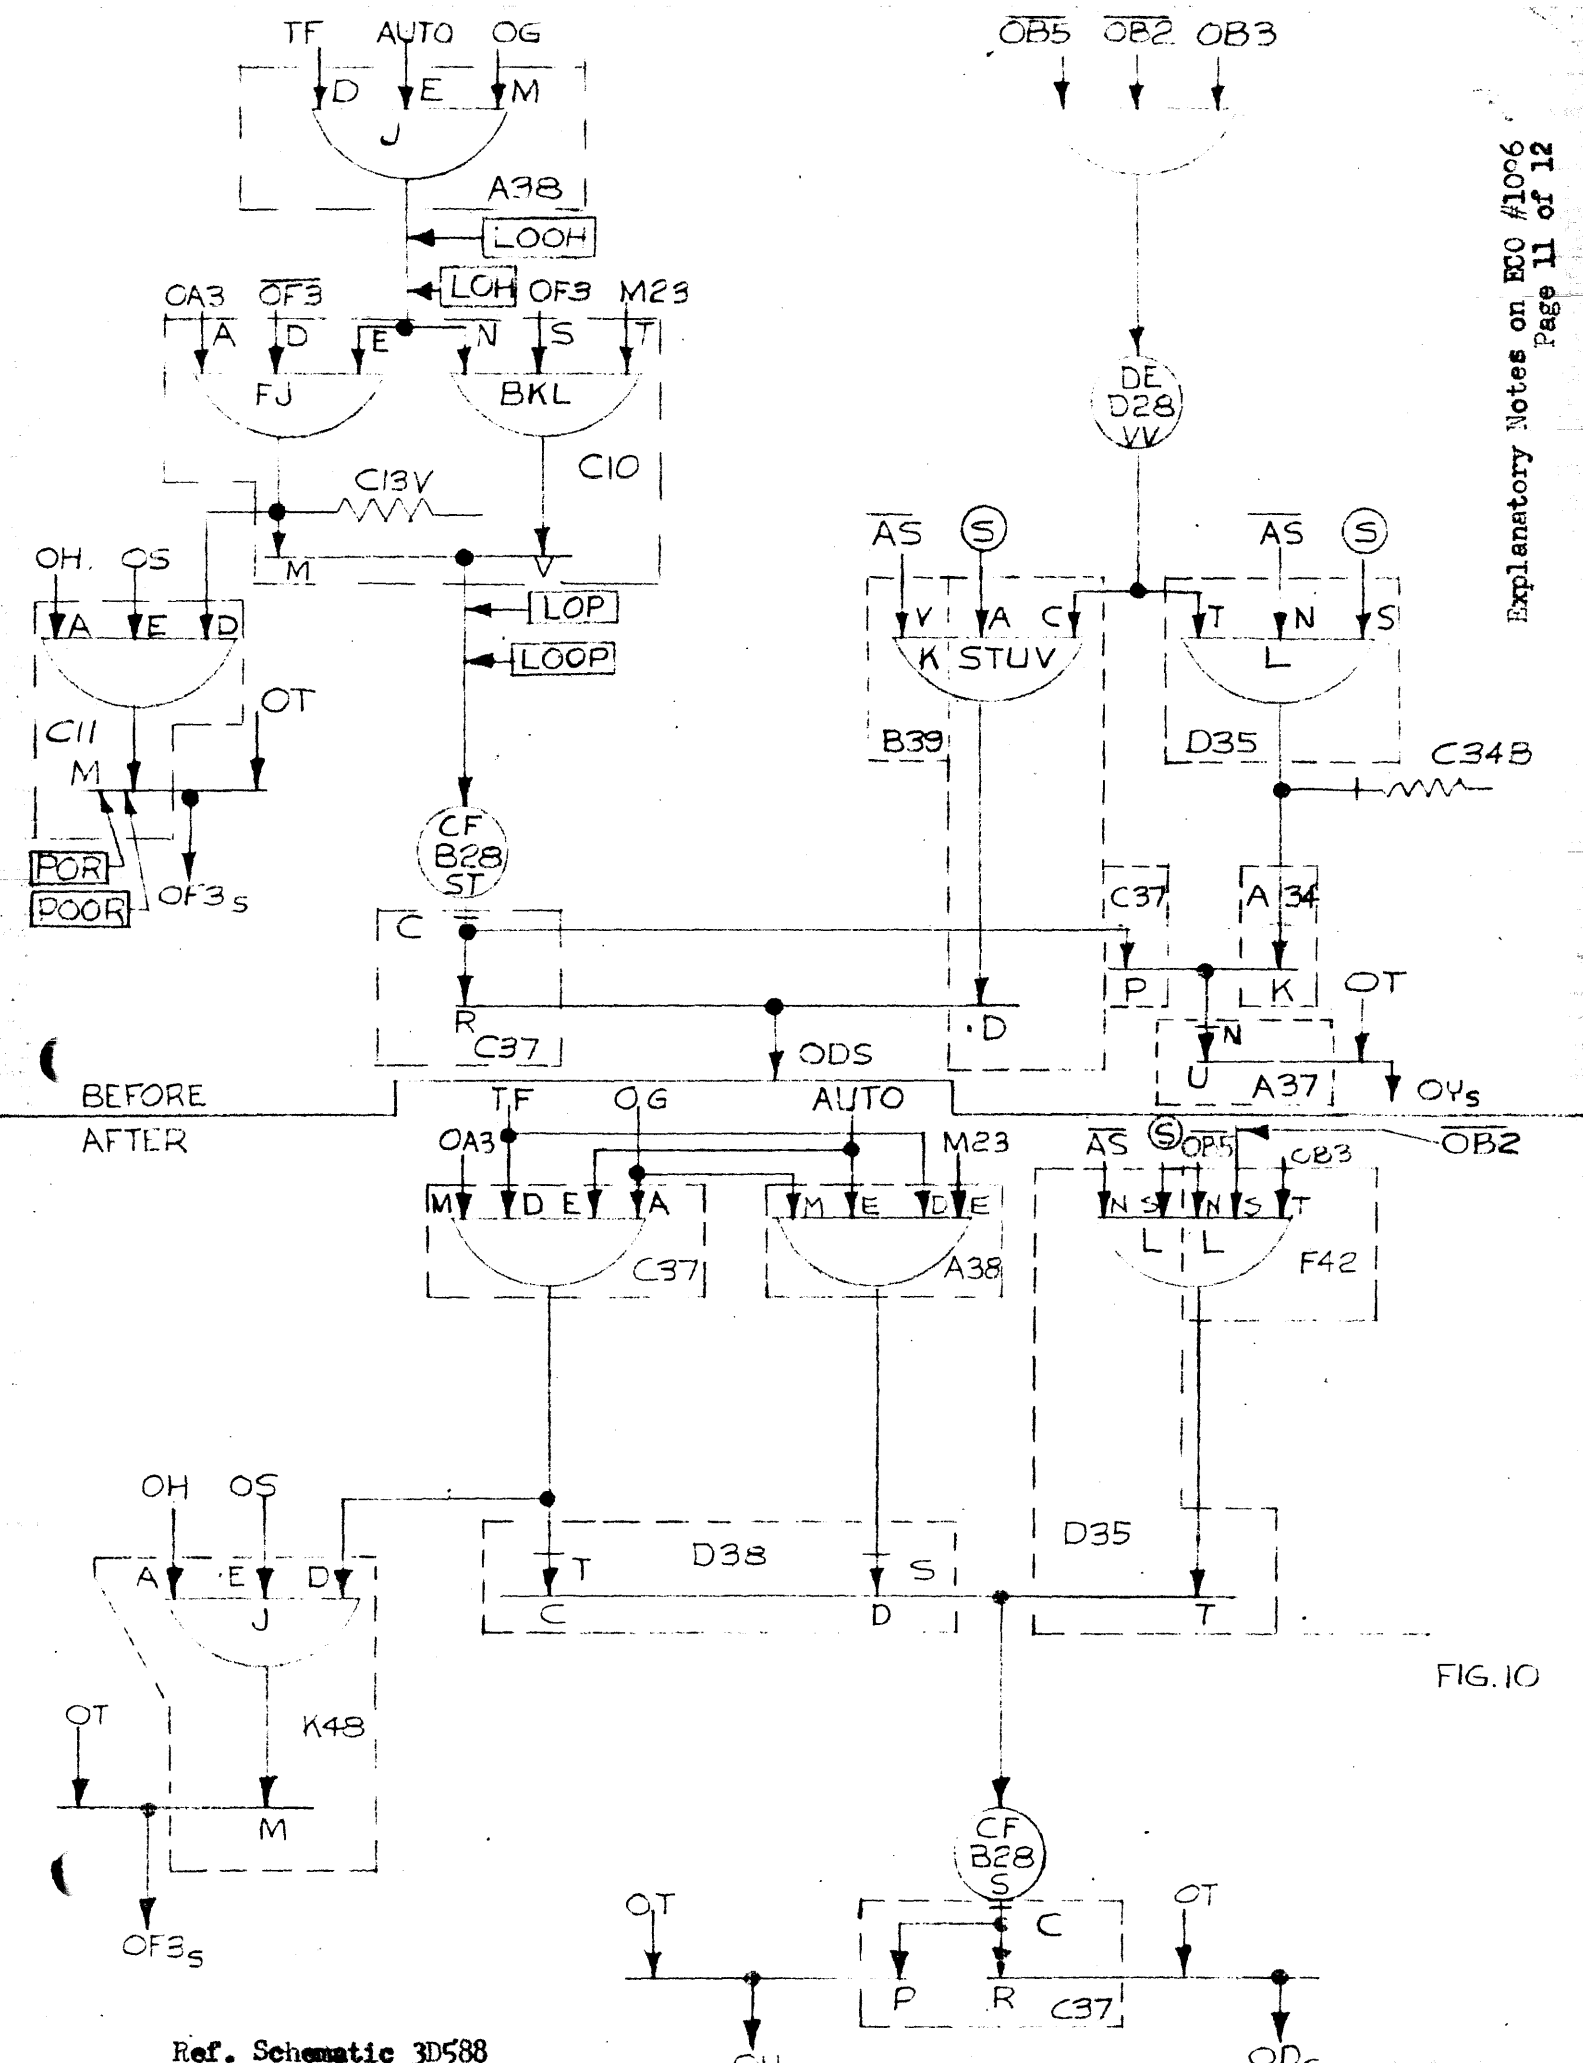
FIG. 9

To simplify the logic and use less hardware, many redundant terms are removed. (See figures 9, 10, and 11)
