- Capacitance in microfarads unless otherwise indicated.
- Keyboard manufactured by Mechanical Enterprises.
- These drawings are based on a reverse engineering of unit with serial number 002833. Components in this unit are stamped with date codes in the range 8009 to 8139.
- 2 \* 2732 EPROMS / V2.13.0 & V2.13.1 : firmware ROM  
 1 \* EA 8316E517 / CROM003 : 2048\*8 character ROM  
 1 \* Z80 : CPU  
 1 \* 6845 : CRT Controller  
 1 \* 2651 : UART  
 6 \* 2114 : RAMs  
 2 \* NEC D444C : 1024\*4 CMOS Static RAM for non-volatile memory.

## Falco TS-1 Terminal

Section: Notes

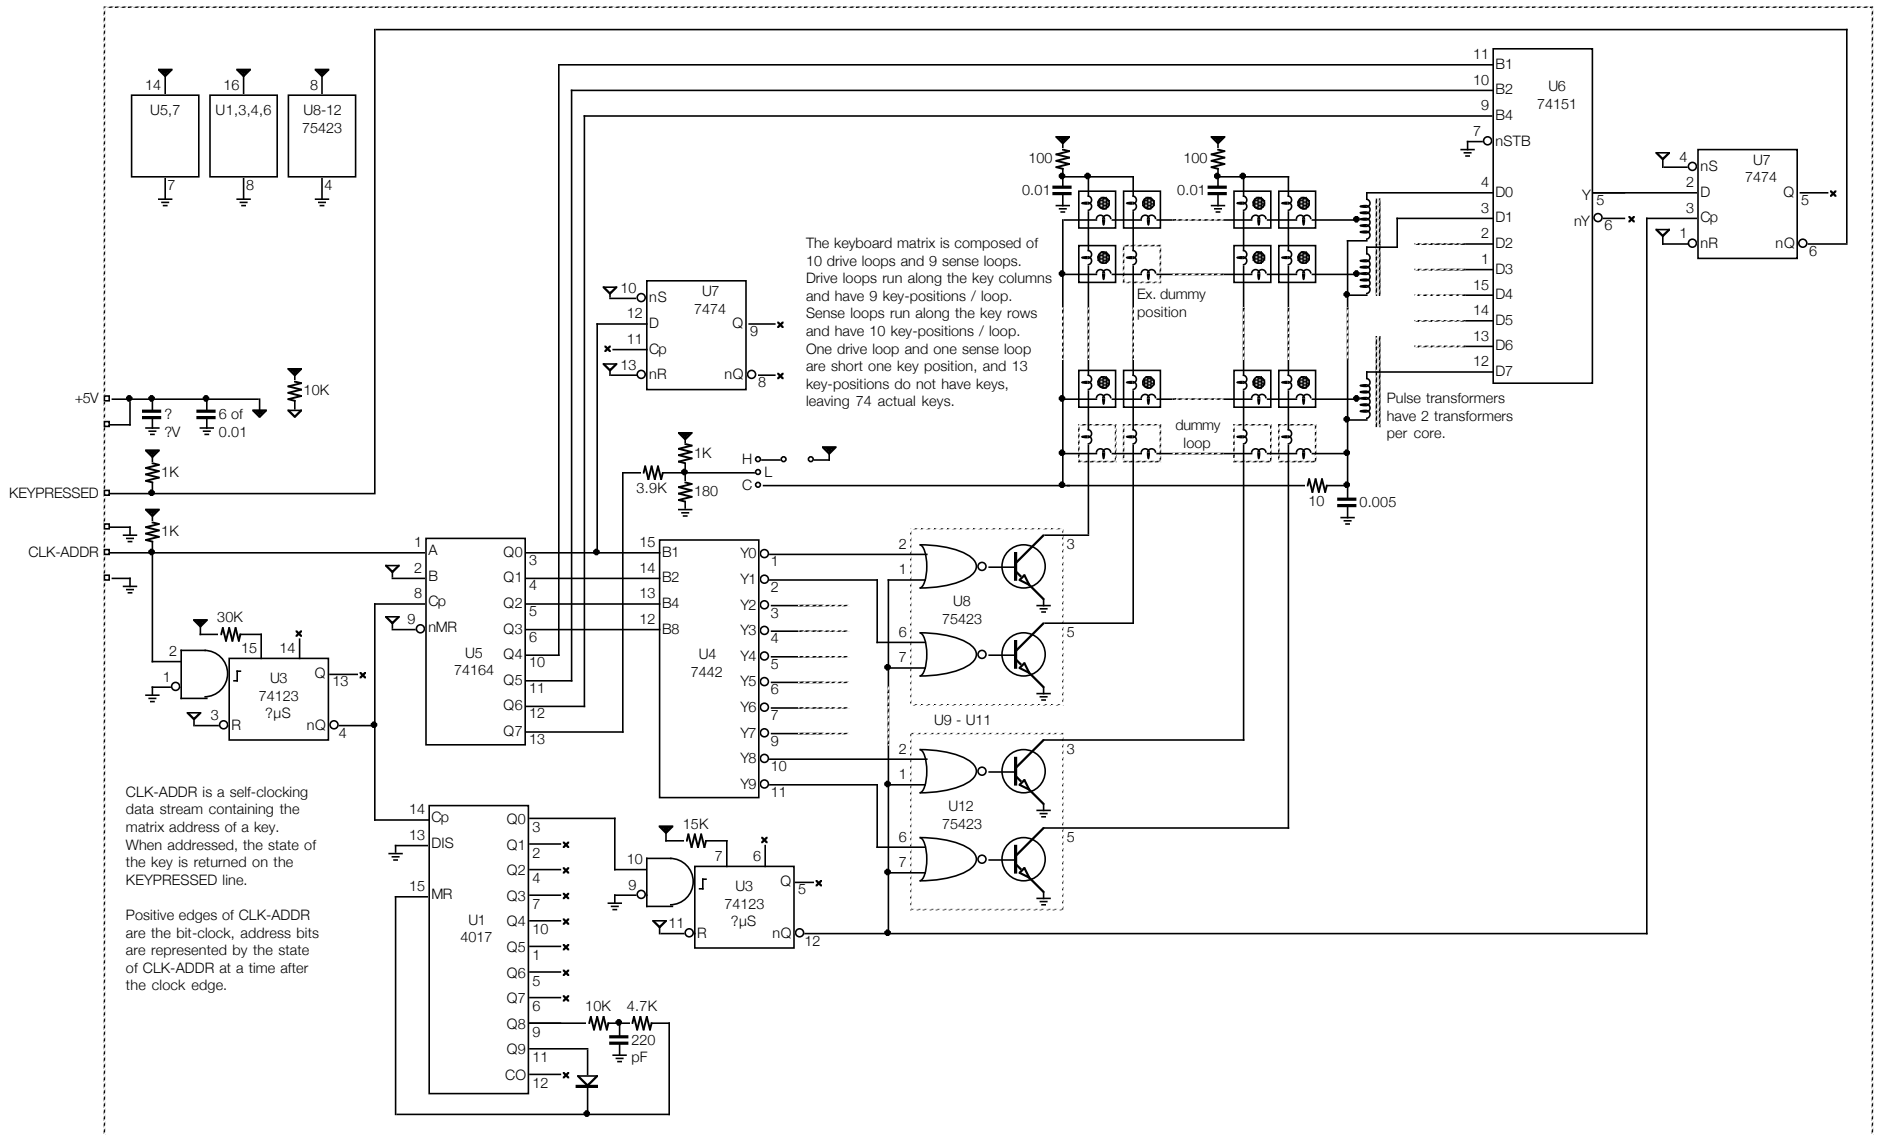
Section: Keyboard

- 2012 Apr: Received.
- 2012 Apr: **\*\*NOTE\*\*** NiCd cells for non-volatile memory appear to be from 1993 (0993). Might best be replaced with alkaline cells to avoid leaking problems.
- 2012 May: Keyboard does not function when first powered on. May start working some minutes after power-up.

Outputs from 4017 not correct, does not appear to be being reset. Soldering around reset circuit previously reworked, diode connection was open.

Diode replaced, and soldering redone, seems reliable. Bad 4017 other possibility if not.
- 2014 May: Horizontal width & linearity, and focus, adjusted to widen raster.
- 2014 May: Right side keys of numeric keypad not working.  
 Foil broken on PCB at U4.11, patched.
- 2014 Jun: 3 ROMs dumped.
- 2014 Jun: Qwerty-section '4' key plunger broken in fall. Glued back on and plunger moved to numeric-pad '0', which has two plungers. If glue fails, might try melting hot-wire into plastic for reinforcement.  
 Plunger/housing for RETURN key also noted to be worn, leaving key sloppy.  
 Plunger/housing swapped with SPACE key which has additional support from balancing bar.
