# Surface analysis and characterization of large printed-circuit-board circuitization process steps

by D. J. Auerbach  
C. R. Brundle  
D. C. Miller

**We describe our use of surface-analysis techniques to characterize problems encountered in 1980-1981 in the fabrication of large printed circuit boards for the IBM 3081 processor unit. XPS, AES, SAM, SEM, and optical microscopy techniques were used. The two major areas addressed were (a) corrosion at a photoresist/Cu foil interface during electroless Cu plating of circuit lines which resulted in defects in subsequently formed Cu lines, and (b) surface-chemical aspects of a "single-seed" colloidal Pd/Sn catalytic initiation of electroless Cu plating onto epoxy surfaces. The corrosion mechanism responsible for the line defects was identified, and corrective actions suggested. Changes in surface composition (Pd/Sn ratio), and surface chemical state ( $\text{Pd}^0/\text{Pd}^{2+}$ ,  $\text{Sn}^0/\text{Sn}^{2+,4+}$ ) as a function of process step were correlated with plating effectiveness and led to a means of increasing the surface  $\text{Pd}^0/\text{Sn}$  ratio by as much as an order of magnitude.**

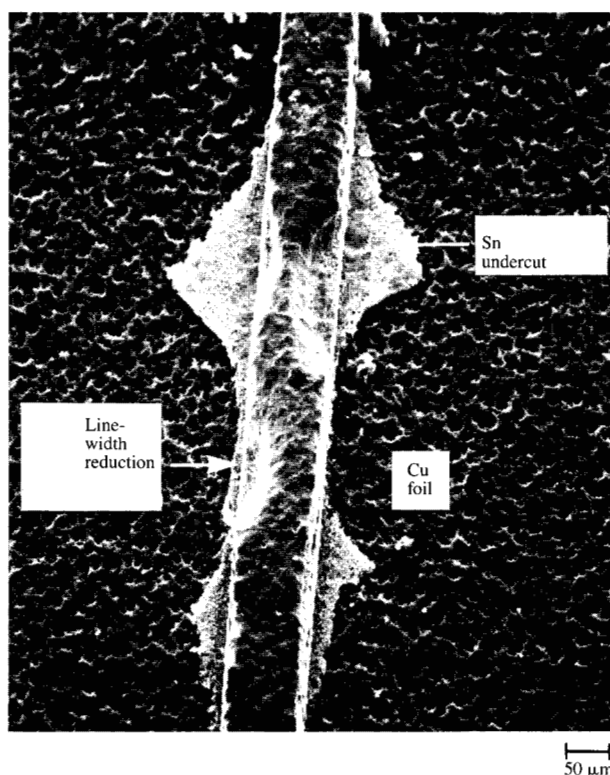
**Figure 2**

Scanning electron micrograph of a plated circuit line after step 8 of Figure 1, illustrating the two problems associated with resist delamination occurring during the Cu deposition stage (step 6): Sn was deposited not only on the Cu line, but also in "flares" on either side (Sn undercut); line-width reductions of the Cu line (the second problem) are apparent.

Functional difficulties of two types resulted from problems in the fabrication steps outlined above and were associated with an apparent photoresist adhesion problem. The first and most serious was "tin undercutting." For boards which exhibited a delamination of the photoresist next to the circuit lines, the Sn plating process (step 7) resulted in the deposition of Sn not only on the Cu lines, where it was needed, but also well to each side of the lines underneath the resist. Since areas covered by Sn were protected during the Cu etching (step 9), areas next to Cu lines where the Sn had penetrated were not etched away. The unetched Sn-covered Cu violated electrical specifications and led to a risk of shorts between lines. (See Figures 2 and 3.) The second problem, which was more ubiquitous than the Sn undercutting, was that the plated Cu lines adjacent to resist-failure regions did not have the desired uniform rectangular profile. Frequent line-width reductions and other defects occurred where Cu plating had apparently ceased locally and Cu was partially absent from the lines. This is also illustrated in Figures 2 and 3. Such lines did not meet dimensional specifications and could lead to failure during test cycling.

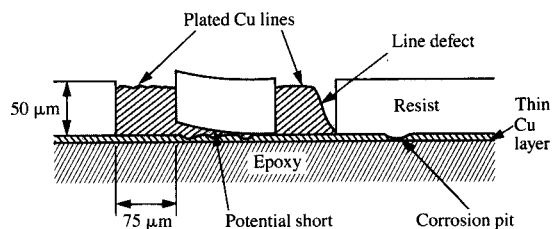
Figure 3

Schematic cross-sectional view through a signal layer after removal from the electroless plating bath (step 6). This illustrates the effects of corrosion and subsequent resist delamination.

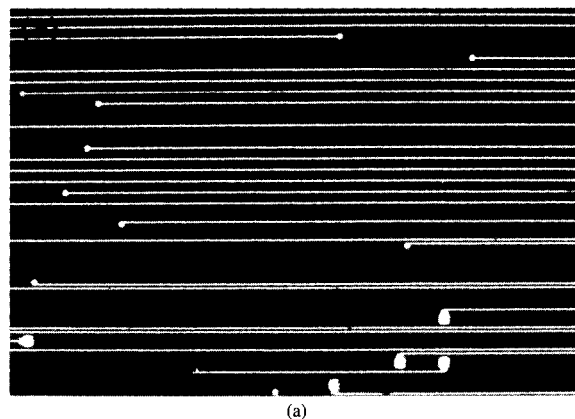
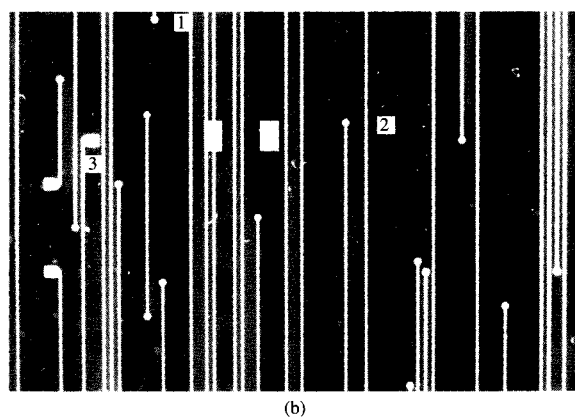
Figure 4

The difficulties described above were associated with apparent failures in photoresist adhesion. Figure 4(a) is a magnified photograph of a region of a board after it had been subjected to all the fabrication steps through the completion of the electroless Cu plating (step 6). The Cu lines had been plated to their full ~50-μm thickness and the resist, which was red, was still on the board. Figure 4(b) is a photograph of a board which exhibited widespread problems after the electroless plating process. In many places the resist adjacent to the plated lines appeared to be darkened, with black spots present within these regions. Examining the board with lighting at a grazing angle revealed that the resist was slightly bubbled above many, though not all, of the black spots. Of particular note was the very striking pattern dependence of the damaged regions. They were found only adjacent to Cu lines which were well spaced (greater than 1-3 mm) from other Cu lines. This pattern dependence was observed on all boards we examined that had damaged regions. Upon removal of resist from a damaged region, which could usually be achieved by flexing cutout sections of

Photograph of portions of two circuit boards after completion of process steps up to and including electroless Cu plating, but before resist removal. The scale can be judged from the widths of the Cu plated lines, which are approximately 74 μm (see Figures 2 and 3). Photograph (a) shows a "normal" board. Photograph (b) shows Cu lines on a board exhibiting severe resist deterioration adjacent to Cu lines that are widely spaced from each other (see text).

the board a few times, the color of the removed resist was found to be actually the same as that of resist removed from undamaged regions. The apparent darkening observed with the resist on the board was actually a darkening of the Cu surface beneath the resist; the black spots were actually on the Cu surface. If an intact bubbled-resist region was sectioned through the bubbles, extensive amounts of foreign material were found in most, but not all, of the bubbles. Another visual observation of significance was that the black spots on the Cu surface were fairly regularly distributed. Their centers generally fell 0.6–0.8 mm from a plated line, and they never touched a line. Any proposed mechanism for the "resist failure" had to account for all the visual features described above, including the striking pattern dependence.

It is important to note that the line defects were correlated with the pattern dependence of the resist failure; i.e., they occurred more frequently and grossly on widely spaced lines than on closely spaced lines. It was not possible, in general, to associate the location of a particular defect with a particular black spot. However, where there was a higher density of black spots, there was a higher density of line defects.

Examples of CSL and WSL areas are indicated as 2 and 3, respectively, in Figure 4(b).

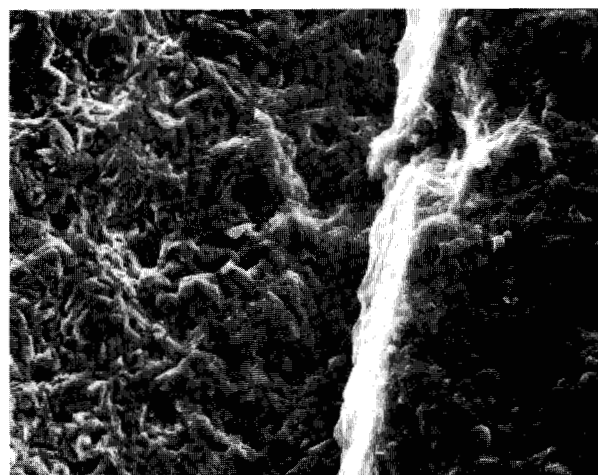
**Figure 5**

Examination using SEM indicated that the surface topography of Cu foil in an isolated area was quite distinct from that of the plated Cu (Figure 5). Scanning electron micrographs of CSL areas showed a sharp demarcation between the plated Cu topography and the adjacent Cu foil topography. Scanning electron micrographs of WSL areas showed a more gradual change as one moved away from the plated lines. Given other data presented below, we believe this indicated that the Cu plating was taking place underneath the resist adjacent to widely spaced lines.

Scanning electron micrograph of a portion of a board showing electroless plated Cu line and adjacent unplated Cu foil, illustrating the difference in morphology of the foil and plated regions.

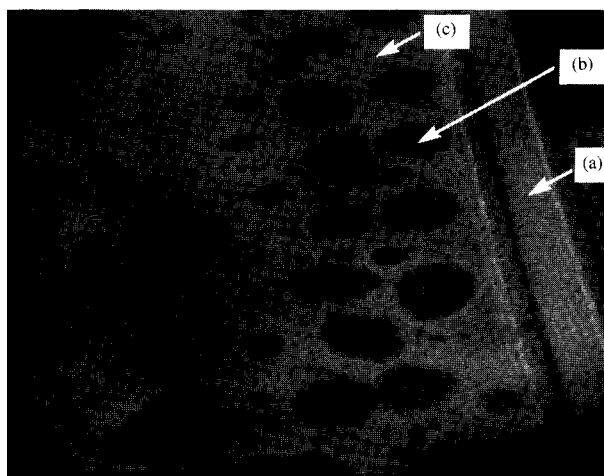
**Figure 6**

Total absorbed current micrograph of area of board containing black spots, obtained using an Auger electron spectrometer. Regions for Auger electron analysis are marked. The scale may be judged from the plated lines, which are approximately 75  $\mu\text{m}$  in width.

shows a much lower apparent Cu concentration in XPS than in AES, which is the case in comparing Tables 1 and 2. The significant results are that the trends observed in XPS were confirmed and additional information was provided concerning the individual black spots. The BTA nitrogen was completely absent only inside the black spots. Adjacent to them, in the rest of the WSL regions, a low level (lower than in the CLS area) was still present. In addition, the oxide in the black spots gave an indication of being thicker than in the areas adjacent to them, since the light  $\text{Ar}^+$  etching, which removed the carbon contamination rapidly, revealed a greatly enhanced O Auger signal within the black spot. This

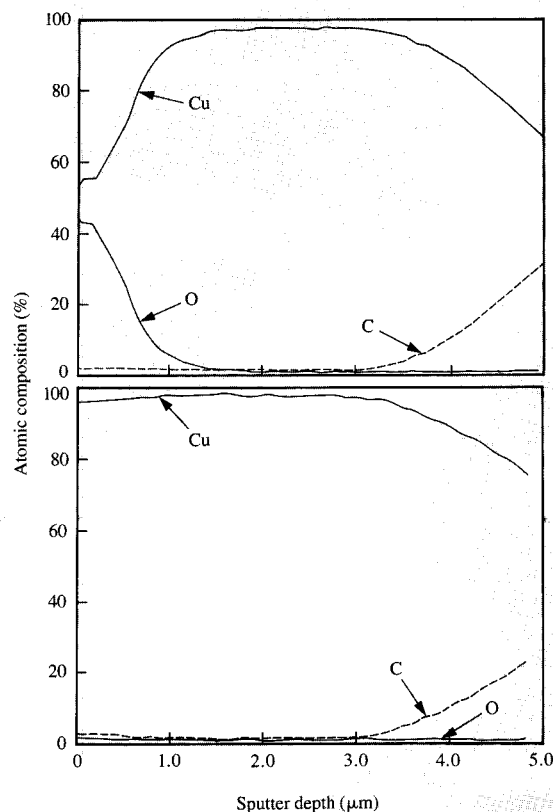
**Figure 8**

Since it appeared that there was a deeper oxide layer in the black spots than elsewhere, we depth-profiled through the 5- $\mu\text{m}$  thickness of the Cu foil in a black-spot region. The result, shown in Figure 8, was quite dramatic. The black spot was found to be oxidized to a depth of some 2  $\mu\text{m}$ , and was clearly a corrosion pit. Profiling adjacent to the black spot or in a CSL region showed that the contamination and oxide layers there were only of superficial thickness.

Cu and O atomic concentration depth profiles of a black spot (upper curve) and of an isolated area of the Cu foil. The black spot was thus shown to be an oxidized area of considerable depth.

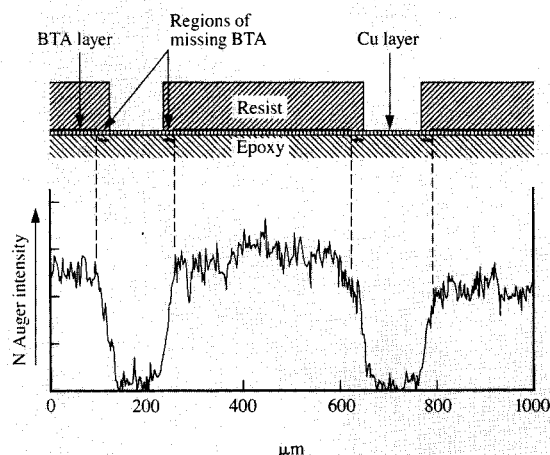
**Figure 9**

Nitrogen concentration variation, measured using the N Auger signal intensity, in a line scan across the line channels of a board after the HCl cleaning procedure (step 5). To obtain this scan, the resist was removed from the board prior to analysis. The upper part of the figure shows how the line scan was geometrically associated with the channel regions. The lack of a nitrogen Auger signal indicated a lack of BTA. Note that the HCl cleaning removed BTA not only at the bottom of the line channels, but also in regions under the resist adjacent to the line channels (see text).

clean had itself penetrated the Cu foil/resist interface and attacked the BTA. Thus the corrosion protection for the Cu foil surface adjacent to the line channels was missing, and the Cu foil/resist interface was weakened even before the boards were subjected to plating.

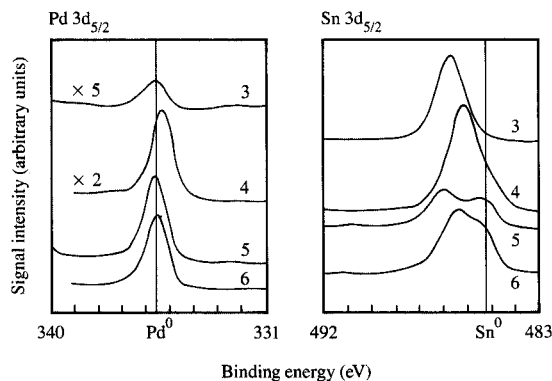
**Figure 10**

Pd and Sn X-ray photoelectron spectra of epoxy substrate after the indicated steps in the single-seed process: 3, immersion in single-seed solution; 4, first rinse; 5, HCl acceleration; 6, final rinse. The elemental concentrations are proportional to the signal intensities, and the chemical state can be determined from the measured binding energies (see text).

Looking at Table 3 and Figure 10, we can see that after the initial immersion in seeder (step 3), only a very small amount of Pd (which was in the metallic Pd<sup>0</sup> state) was observable within the probing depth (~30 Å) of the analysis. There was an amount of Sn 25 times greater, all of it in the oxidized Sn<sup>2+</sup> or Sn<sup>4+</sup> state. The large carbon signal arose mainly from the epoxy substrate. The chlorine (in the form of Cl<sup>-</sup> from the observed BE) arose from the Cl<sup>-</sup> counterions of the colloidal particle complex. The F<sup>-</sup> was initially a surprise to us, but we later learned that a fluorocarbon wetting agent is an additive to the commercial seeding solution. Sulfur and sodium were ubiquitous contaminants.

After the DI rinse (step 4) the fluorine, sulfur, and sodium signals were gone and the chlorine signal reduced dramatically. Consequently, all the other signals increased. The Pd/Sn ratio, however, increased by a factor of 5, and the Sn 3d<sub>5/2</sub> peak position suggested that some of the Sn observed was in the metallic form (Figure 10). The acceleration step (5) increased the amount of Pd<sup>0</sup> by a factor of two, decreased the amount of Sn by a factor of two, and replaced oxygen counter-ions with chloride. The Sn within the probing depth was roughly 50/50 metallic/oxidized. The final rinse (step 6) replaced chlorine with oxygen again, but changed little else.

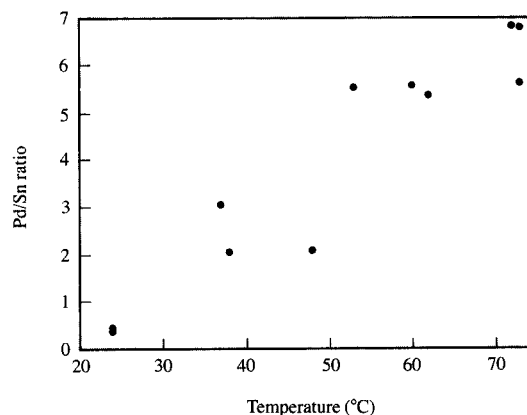
**Figure 11**

Surface Pd/Sn ratio (determined by XPS) for single-seeded epoxy substrates accelerated with 5 mM NaOH for three minutes as a function of temperature. An improvement of more than an order of magnitude was obtained at  $73^\circ\text{C}$ , compared to the standard single-seed acceleration process (see text).
