intel® Technical Advisory

TA-0414-05

Timing Margin Increased On SKA4 Baseboards

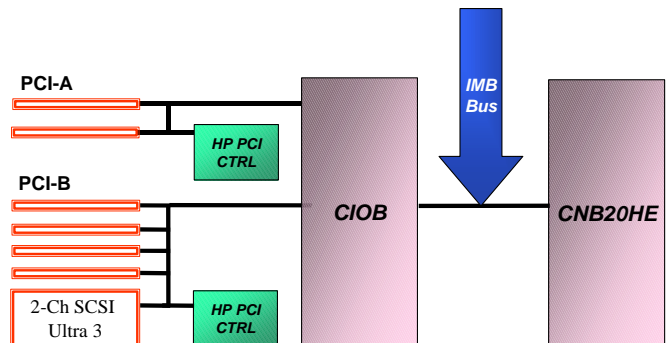
SKA4 Baseboard Focus Sub-section

Intel has confirmed the possibility of compressed clock signals on the chipset downstream IMB bus between the Serverworks Serverset III HE*, "CIOB" and "HE" ASICs, causing a resulting timing margin loss relative to the data signal in the downstream direction. Intel's investigation indicates that due to the intermittent nature of the issue, manufacturing tests may not have screened this issue completely and therefore some exposure in the installed base is probable on all 751519-5xx, and 751519-603 baseboards.

The margin loss caused by the compressed IMB clock signals could potentially cause incorrect data transfer at the CIOB resulting in an undetected disk write error or other undetected PCI write error.

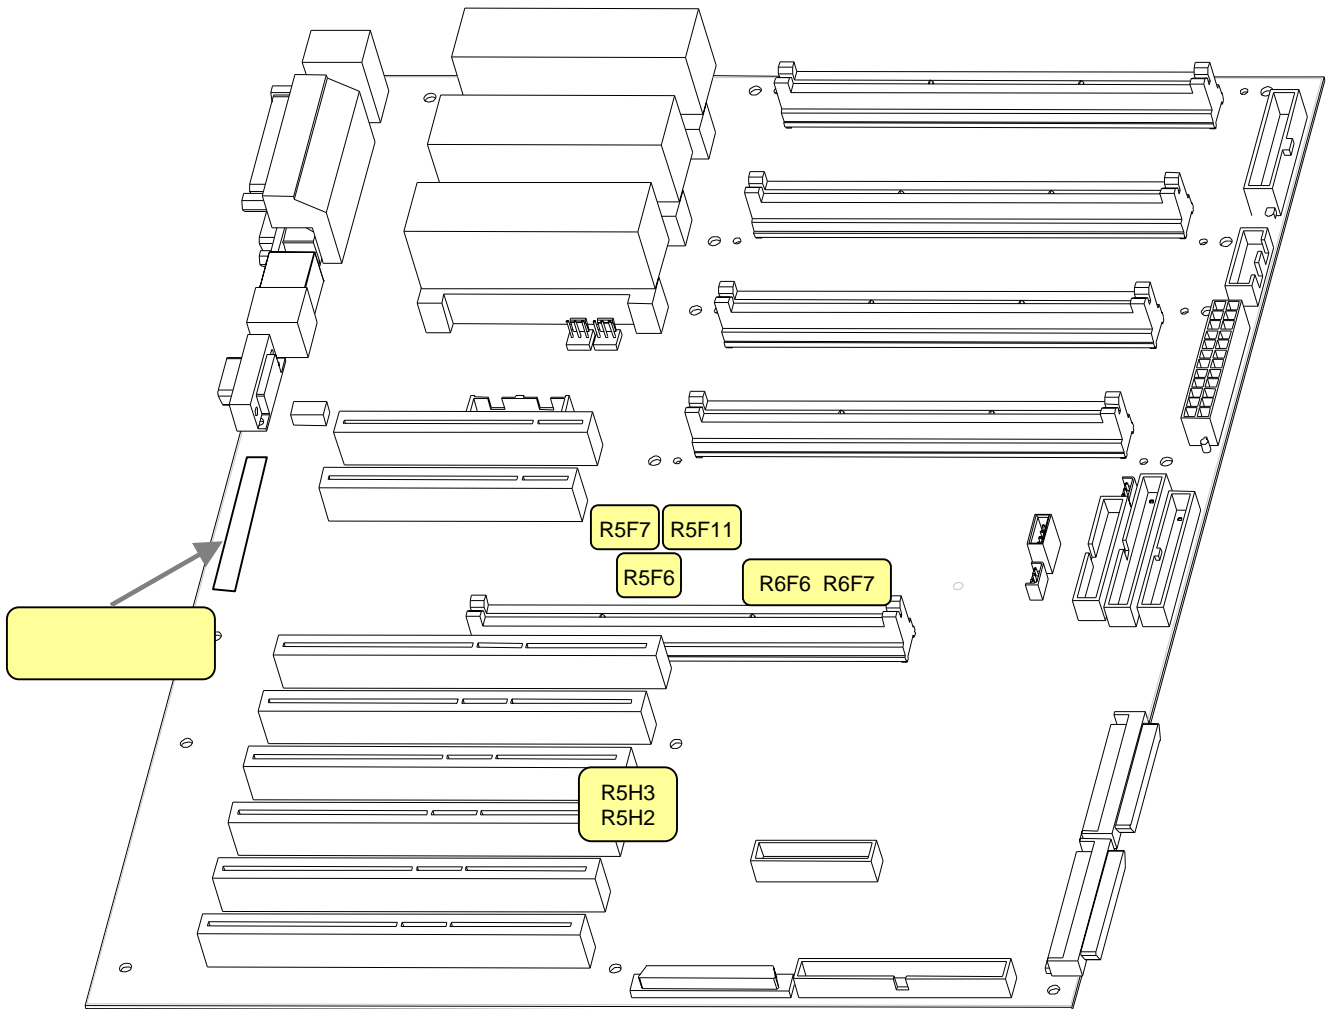
SKA4 Baseboard Resistor and Label Locations.

The SKA4 baseboard revision number is indicated on a white label near the IO connector space on the board. It will be in the form of PBA 751519-xxxx where "xxxx" is a three digit number followed by an optional letter indicating the actual revision of the board. Please refer to the baseboard layout diagram for location information

Intel has implemented a resolution to this issue by reconfiguring the chipset IMB bus. The resolution involves changing the baseboard by removing three resistors and adding four other resistors as shown below. These changes configure the chipset IMB bus to provide additional timing margin. As a result, the PCI-A bus will continue to be set at an operating speed of 33 MHz to match system specifications and the option to change this bus speed to 66 MHz via BIOS setup is removed.

Remove the resistors from the following locations:

R5F7
R6F6
R5H3

Add resistors to the following locations:

R5F11 (0 ohm, 5%, 1/16W)
R5F6 (0 ohm, 5%, 1/16W)
R6F7 (1k, 5%, 1/16W)
R5H2 (1k, 5%, 1/16W)
