## Analysis of Defect Distribution in Transistor Structures with Reflection and Transmission X-Ray Topography

**Abstract:** Reflection and transmission x-ray topography can be combined to isolate and identify dislocations that penetrate the active junctions of transistor structures in integrated circuit wafers. This is accomplished by reconstructing the defect distribution normal to the surface as viewed in transmission (volume-sensitive) and reflection (surface-sensitive) x-ray topography. The combination of surface and bulk observations is exploited to demonstrate the effect of dislocation density on pipes (low-resistance paths from emitter to collector). A method is also described for estimating the depth of defect visibility in reflection x-ray topography.

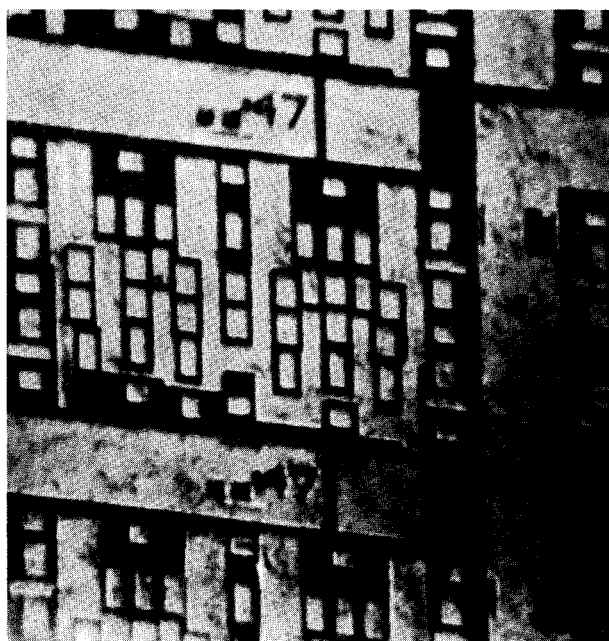
**Figure 6** A surface topograph of another wafer section. The test transistor at the top of the figure yielded a leakage current of  $240\mu\text{A}$  as compared with  $1300\mu\text{A}$  for the lower chip. This is consistent with the observed dislocation density in each chip.

An additional wafer was selected for device-defect study, but in this case the sample contained minimal slip, as verified by a transmission x-ray topograph. Figure 6 shows an enlarged area of a reflection topograph that depicts several integrated circuit chips and two test transistors. The leakage current of the upper test transistor was  $240 \mu\text{A}$ ; the low leakage is in agreement with the low density of dislocations in the reflection topograph. Note that the lower chip, however, has considerably more dislocations (Fig. 6) than the upper junction. The leakage current was observed to increase to  $1300 \mu\text{A}$ , in correspondence to the increased defect density. Figure 7 is another reflection topograph from the same wafer, but closer to the edge. Note that the dislocation density is considerably higher than in Fig. 6. The increase in leakage current to  $2000 \mu\text{A}$  is in agreement with the increased dislocation density. The lower chip in Fig. 7 is near the wafer edge; the leakage current of  $4000 \mu\text{A}$  is consistent with the high defect density observed in the reflection topograph.
