# Concurrent driver upgrade: Method to eliminate scheduled system outages for new function releases

The reliability, availability, and serviceability goal for an IBM zSeries® system is to provide 24-hour-per-day, 365-day-per-year service with reduced system downtime. The continuous reliable operation rate has been improved with every new zSeries release by using error prevention, error detection, error recovery, and other methods that contribute to avoiding unplanned interruptions. Until now, planned downtime—for example, the time needed to upgrade a zSeries to the next firmware driver—had not yet been addressed. We developed the concurrent driver upgrade (CDU) feature so that customers could add new functions without downtime. It is now possible to upgrade the zSeries firmware engineering change (EC) driver to the next EC level without any performance impact during the upgrade. This paper describes the motivation and strategy of the CDU and describes its use.

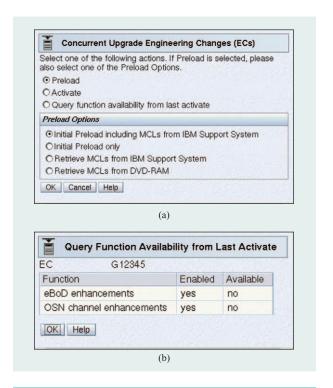
Figure 3

(a) Main CDU option panel; (b) query function availability panel.

**Figure 3(a)** shows the main CDU option panel on the HMC. The first step in the CDU process is to initially preload the alternate SE with the GA<sup>n+1</sup> code while the primary SE and the system continue to operate using the GA<sup>n</sup> code. There are two initial preload options: initial preload including MCLs from the IBM Support System, and initial preload only. Both options put the base GA<sup>n+1</sup> driver on the alternate SE using the CDU DVD-RAM, and the only difference in the two options is that the first option will download any additional fixes that were released after that CDU AROM was released.

By selecting the CDU activate option from the main CDU option panel [Figure 3(a)], the following requirements are verified before the code switch starts:

Once the CDU activate is complete, the operator can invoke the "Query function availability from last activate" option from the CDU option panel [Figure 3(a)] to get an overview of which functions are not yet available or have not yet been enabled after the CDU completion step. **Figure 3(b)** shows a hypothetical resultant panel display from that invocation. This panel addresses the exception cases in which one or more new  $GA^{n+1}$  functions cannot be made available during the CDU activation process.
